**Flood Control Project Maintenance
Levee Inspections**

Fall 2016 Levee Maintenance Deficiency Summary Report

Sacramento River Basin

NA0001	Overall LMA Rating	Total LMA Miles						
American River Flood Control District	A	34.47						
Rated Item	Maintenance Deficiency				Enforcement		Design & System Obsolescence	
	M Miles	U Miles	M + 4U Miles	Threshold %	M Miles	U Miles	M Miles	U Miles
<i>Earthen Levee</i>								
Vegetation	0.05		0.05	0.15%	0.73	0.38		
Encroachments					1.07	3.34		
Animal Control	0.02		0.02	0.06%				
Slope Stability	0.08		0.08	0.23%				
<i>Supplemental</i>								
2015 USACE Erosion Survey, DRAFT	0.04		0.04	0.12%				
DWR UCIP Field Study					0.96	0.07		
<i>LMA Totals:</i>	0.19	0.00	0.19	0.55%	2.76	3.79	0.00	0.00
Unit No. 01 Arcade Creek LB	Overall Unit Rating	Total Unit Miles						
NA0001	A	2.08						
Rated Item	Maintenance Deficiency				Enforcement		Design & System Obsolescence	
	M Miles	U Miles	M + 4U Miles	Threshold %	M Miles	U Miles	M Miles	U Miles
<i>Earthen Levee</i>								
Vegetation	0.01		0.01	0.48%	0.04	0.03		
Encroachments					0.30	0.27

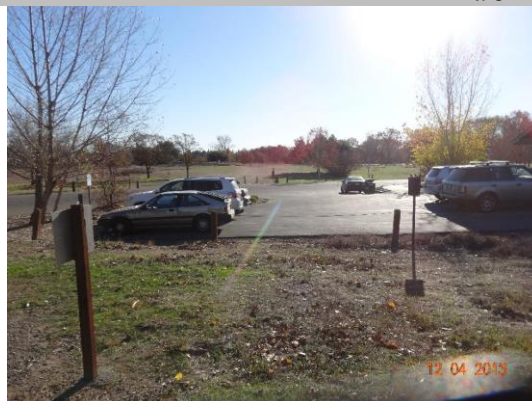
Photo 2 of 2 : UCIP_FA_2016_31450_57500.jpg

LM Start	0.62	Rating **	M	Issue No.	122 (cont)	
LM End	0.62	Issue Type +	En	Location *	CR	
Category	Supplemental			GPS Latitude/Longitude		
				Start	End	
Item	DWR UCIP Field Study			38.592105 °	38.592105 °	
				-121.334423 °	-121.334423 °	
DWR ID						
Comment Code						
Inspector Comment						
FS_ID:31450						
DS_ID:24820						
EP_NO: N/A						
Repair Type: Non-Urgent						
Crossing Status: Indicator Found						
UCIP Comments: Unable to determine alignment of crossing, does it cross levee? Permit?						
FIELD_STRUCT_DESC: Protective posts located on landside (LS) for what appears to be for gas/petroleum line. Unable to confirm if line goes through levee or if line runs parallel. No permit found.						
FS Date: 12/4/2013

No signs of crossing on waterward side.

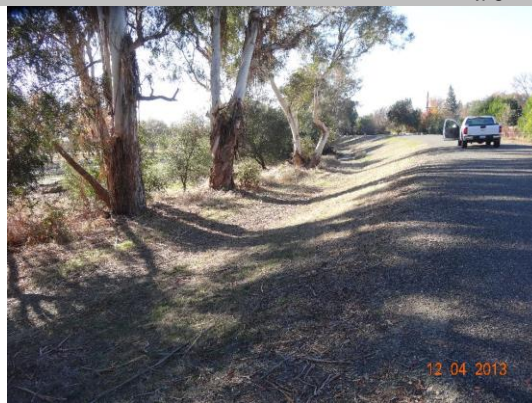
Photo 1 of 2 : UCIP_FA_2016_26281_47492.jpg

LM Start	0.72	Rating **	M	Issue No.	118
LM End	0.72	Issue Type +	En	Location *	CR
Category	Supplemental			GPS Latitude/Longitude	
				Start	End
Item	DWR UCIP Field Study			38.591003 °	38.591003 °
				-121.335459 °	-121.335459 °
DWR ID					
Comment Code					
Inspector Comment					
FS_ID:26281 DS_ID:24464 EP_NO: 12725 Repair Type: Non-Urgent Crossing Status: Indicator Found UCIP Comments: Unable to confirm if this crossing is the same under permit 12725. Drinking fountain and water flow prevention located on waterward side. Need to coordinate with American River Flood Control District. FIELD_STRUCT_DESC: 6-inch steel water pipe through the levee, 2.5 feet below the crown. Arcade Water District well at landside (LS) toe. (Permit No. 12725-1980) FS Date: 12/4/2013

View of waterward slope.

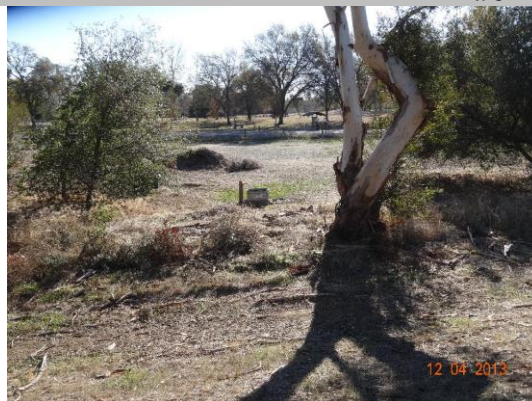
Photo 2 of 2 : UCIP_FA_2016_26281_47493.jpg

LM Start	0.72	Rating **	M	Issue No.	118 (cont)	
LM End	0.72	Issue Type +	En	Location *	CR	
Category	Supplemental			GPS Latitude/Longitude		
				Start		End
Item	DWR UCIP Field Study			38.591003 °		38.591003 °
				-121.335459 °		-121.335459 °
DWR ID						
Comment Code						
Inspector Comment						
FS_ID:26281 DS_ID:24464 EP_NO: 12725 Repair Type: Non-Urgent Crossing Status: Indicator Found UCIP Comments: Unable to confirm if this crossing is the same under permit 12725. Drinking fountain and water flow prevention located on waterward side. Need to coordinate with American River Flood Control District. FIELD_STRUCT_DESC: 6-inch steel water pipe through the levee, 2.5 feet below the crown. Arcade Water District well at landside (LS) toe. (Permit No. 12725-1980) FS Date: 12/4/2013

View of faucet located on waterward side.

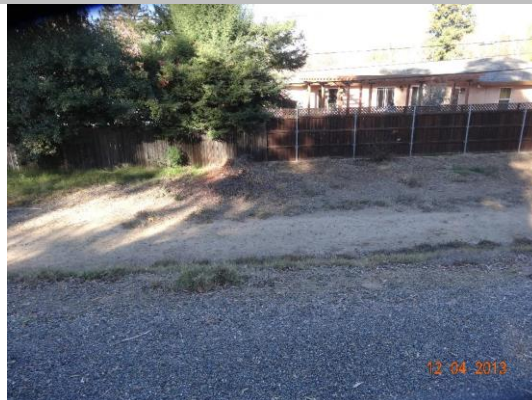
Photo 1 of 2 : UCIP_FA_2016_41550_47496.jpg

LM Start	0.94	Rating **	M	Issue No.	129
LM End	0.94	Issue Type +	En	Location *	CR
Category	Supplemental			GPS Latitude/Longitude	
				Start	End
Item	DWR UCIP Field Study			38.587989 °	38.587989 °
				-121.336773 °	-121.336773 °
DWR ID					
Comment Code					
Inspector Comment					
FS_ID:41550 DS_ID:24413 EP_NO: 2806 Repair Type: Non-Urgent Crossing Status: Found UCIP Comments: Need to determine status of crossing--Need to coordinate with utility owner. FIELD_STRUCT_DESC: 30-inch corrugated metal (CM) pipe through the levee, 15.0 feet below the crown. Cutoff wall around pipe under landside (LS) shoulder. Flap gate and slide gate in concrete pipe well on the waterside (WS) shoulder. Large drain canal cut across the WS berm. (Permit No. 2806-1958) FS Date: 12/4/2013

View of landward side.

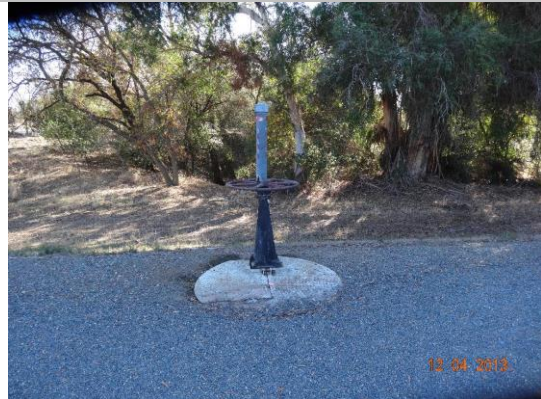
Photo 2 of 2 : UCIP_FA_2016_41550_47495.jpg

LM Start	0.94	Rating **	M	Issue No.	129 (cont)
LM End	0.94	Issue Type +	En	Location *	CR
Category	Supplemental			GPS Latitude/Longitude	
				Start	End
Item	DWR UCIP Field Study			38.587989 °	38.587989 °
				-121.336773 °	-121.336773 °
DWR ID					
Comment Code					
Inspector Comment					
FS_ID:41550 DS_ID:24413 EP_NO: 2806 Repair Type: Non-Urgent Crossing Status: Found UCIP Comments: Need to determine status of crossing--Need to coordinate with utility owner. FIELD_STRUCT_DESC: 30-inch corrugated metal (CM) pipe through the levee, 15.0 feet below the crown. Cutoff wall around pipe under landside (LS) shoulder. Flap gate and slide gate in concrete pipe well on the waterside (WS) shoulder. Large drain canal cut across the WS berm. (Permit No. 2806-1958) FS Date: 12/4/2013

View of gate stem located on waterward shoulder.

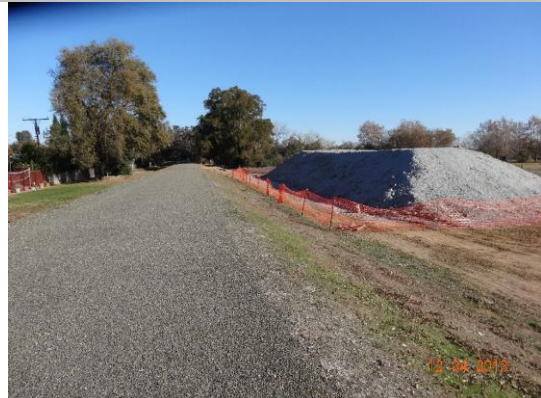
Photo 1 of 2 : UCIP_FA_2016_31284_57285.jpg

LM Start	1.04	Rating **	M	Issue No.	125
LM End	1.04	Issue Type +	En	Location *	CR
Category	Supplemental			GPS Latitude/Longitude	
				Start	End
Item	DWR UCIP Field Study			38.586813 °	38.586813 °
				-121.337643 °	-121.337643 °
DWR ID					
Comment Code					
Inspector Comment					
FS_ID:31284 DS_ID:24821 EP_NO: N/A Repair Type: Non-Urgent Crossing Status: Found UCIP Comments: Unable to determine reason for box and whether there is a utility that crosses levee. No permit found. FIELD_STRUCT_DESC: Service box located on waterside (WS). No permit found. FS Date: 12/4/2013

Overview of levee crown at crossing.

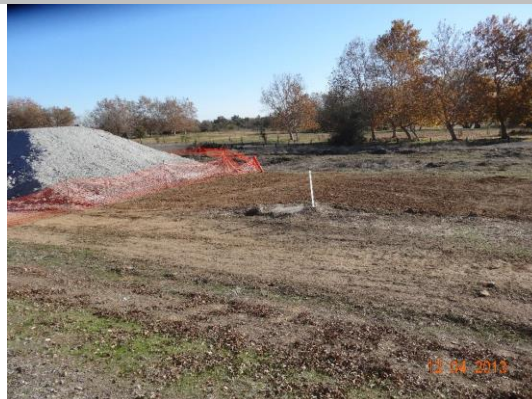
Photo 2 of 2 : UCIP_FA_2016_31284_57286.jpg

LM Start	1.04	Rating **	M	Issue No.	125 (cont)	
LM End	1.04	Issue Type +	En	Location *	CR	
Category	Supplemental			GPS Latitude/Longitude		
				Start	End	
Item	DWR UCIP Field Study			38.586813 °	38.586813 °	
				-121.337643 °	-121.337643 °	
DWR ID						
Comment Code						
Inspector Comment						
FS_ID:31284 DS_ID:24821 EP_NO: N/A Repair Type: Non-Urgent Crossing Status: Found UCIP Comments: Unable to determine reason for box and whether there is a utility that crosses levee. No permit found. FIELD_STRUCT_DESC: Service box located on waterside (WS). No permit found. FS Date: 12/4/2013

Concrete vault located on waterward side.

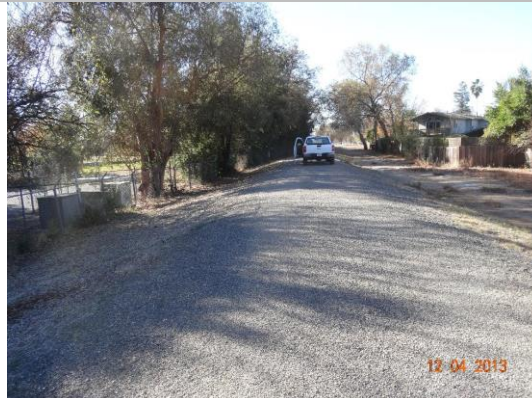
Photo 1 of 2 : UCIP_FA_2016_41536_47550.jpg

LM Start	1.28	Rating **	M	Issue No.	126
LM End	1.28	Issue Type +	En	Location *	CR
Category	Supplemental			GPS Latitude/Longitude	
				Start	End
Item	DWR UCIP Field Study			38.583873 °	38.583873 °
				-121.340037 °	-121.340037 °
DWR ID					
Comment Code					
Inspector Comment					
FS_ID:41536					
DS_ID:24097					
EP_NO: 12276					
Repair Type: Non-Urgent					
Crossing Status: Indicator Found					
UCIP Comments: Unable to find markers indicating crossing through levee.					
FIELD_STRUCT_DESC: Two 3-inch PVC electrical conduits through the levee, 3.0 feet below the crown. Northeast Sewage Treatment Plant on waterside (WS). Conduits extend from treatment plant to transformers located on WS. (Permit No. 12276-1980)					
FS Date: 12/4/2013

Overview of levee looking downstream.

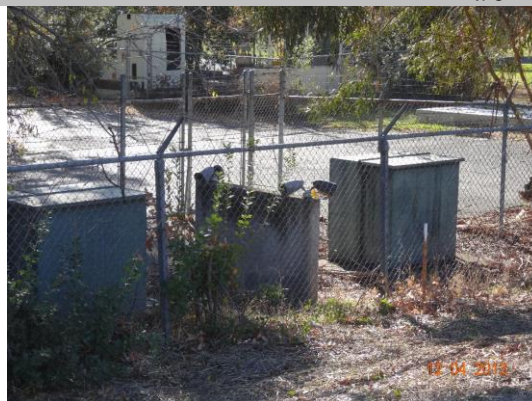
Photo 2 of 2 : UCIP_FA_2016_41536_47549.jpg

LM Start	1.28	Rating **	M	Issue No.	126 (cont)	
LM End	1.28	Issue Type +	En	Location *	CR	
Category	Supplemental			GPS Latitude/Longitude		
				Start	End	
Item	DWR UCIP Field Study			38.583873 °	38.583873 °	
				-121.340037 °	-121.340037 °	
DWR ID						
Comment Code						
Inspector Comment						
FS_ID:41536						
DS_ID:24097						
EP_NO: 12276						
Repair Type: Non-Urgent						
Crossing Status: Indicator Found						
UCIP Comments: Unable to find markers indicating crossing through levee.						
FIELD_STRUCT_DESC: Two 3-inch PVC electrical conduits through the levee, 3.0 feet below the crown. Northeast Sewage Treatment Plant on waterside (WS). Conduits extend from treatment plant to transformers located on WS. (Permit No. 12276-1980)						
FS Date: 12/4/2013

View of transformers located on waterward side.

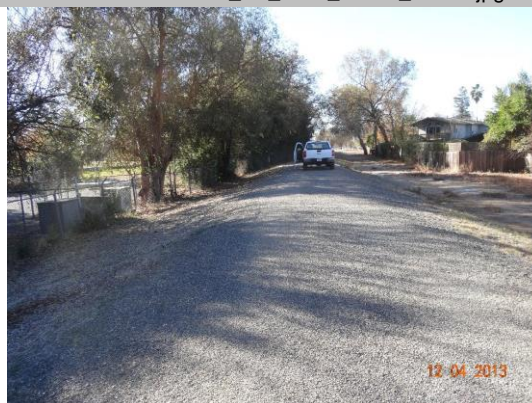
Photo 1 of 2 : UCIP_FA_2016_26299_47575.jpg

LM Start	1.28	Rating **	M	Issue No.	121
LM End	1.28	Issue Type +	En	Location *	CR
Category	Supplemental			GPS Latitude/Longitude	
				Start	End
Item	DWR UCIP Field Study			38.583873 °	38.583873 °
				-121.340037 °	-121.340037 °
DWR ID					
Comment Code					
Inspector Comment					
FS_ID:26299 DS_ID:24477 EP_NO: 7993 Repair Type: Non-Urgent Crossing Status: Found UCIP Comments: Unable to confirm if crossing buried is the same as this crossing. Need to contact owner to confirm utility description. FIELD_STRUCT_DESC: 6-inch plastic lined steel pipe through the levee at unknown depth. Steel cutoff wall around pipe at center of levee. (Permit No. 7993-1973) FS Date: 12/4/2013

Overview of levee crown looking downstream.

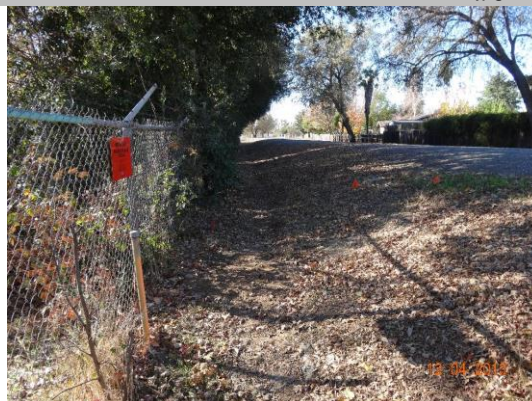
Photo 2 of 2 : UCIP_FA_2016_26299_47574.jpg

LM Start	1.28	Rating **	M	Issue No.	121 (cont)
LM End	1.28	Issue Type +	En	Location *	CR
Category	Supplemental			GPS Latitude/Longitude	
				Start	End
Item	DWR UCIP Field Study			38.583873 °	38.583873 °
				-121.340037 °	-121.340037 °
DWR ID					
Comment Code					
Inspector Comment					
FS_ID:26299 DS_ID:24477 EP_NO: 7993 Repair Type: Non-Urgent Crossing Status: Found UCIP Comments: Unable to confirm if crossing buried is the same as this crossing. Need to contact owner to confirm utility description. FIELD_STRUCT_DESC: 6-inch plastic lined steel pipe through the levee at unknown depth. Steel cutoff wall around pipe at center of levee. (Permit No. 7993-1973) FS Date: 12/4/2013

View of waterward side--Underground Alert System markers showing alignment.

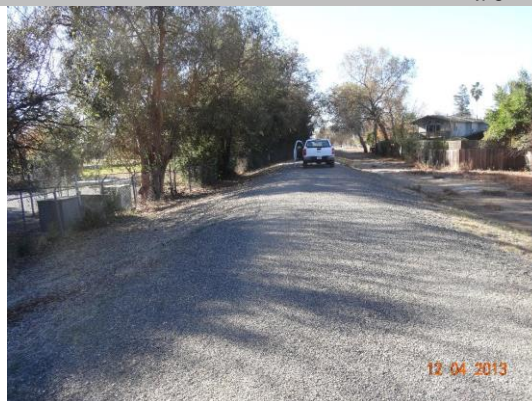
Photo 1 of 2 : UCIP_FA_2016_26296_47558.jpg

Comment Code					
Inspector Comment					
FS_ID:26296 DS_ID:24568 EP_NO: 3599B Repair Type: Non-Urgent Crossing Status: Indicator Found UCIP Comments: Need to determine status of structure-unable to determine if crossing is being used. Only indicator visible during inspection was the underground alert service markers and spray paint visible on the levee crown. FIELD_STRUCT_DESC: 1 of 3: [River Walkway Station] 12-inch concrete encased pipe through the levee, 15.3 feet below the crown. Two cutoff walls around pipe in line with each shoulder. Slide gate in concrete gate structure at landside (LS) toe-not found 2013. Sewage treatment plant on waterside (WS). Control valve in concrete box on the WS. (Permit No. 3599B-1964) Contact: Sacramento Regional Office 875-9400; Oscar Starks (Supervisor) 916-204-5143; Troy Shurock 916-599-2413. FS Date: 12/4/2013

Overview of levee crown looking downstream.

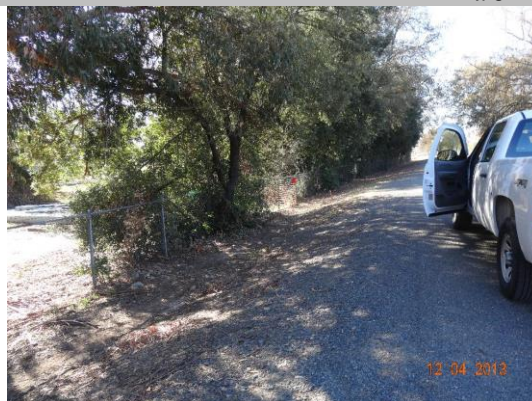
Photo 2 of 2 : UCIP_FA_2016_26296_47559.jpg

Comment Code					
Inspector Comment					
FS_ID:26296 DS_ID:24568 EP_NO: 3599B Repair Type: Non-Urgent Crossing Status: Indicator Found UCIP Comments: Need to determine status of structure-unable to determine if crossing is being used. Only indicator visible during inspection was the underground alert service markers and spray paint visible on the levee crown. FIELD_STRUCT_DESC: 1 of 3: [River Walkway Station] 12-inch concrete encased pipe through the levee, 15.3 feet below the crown. Two cutoff walls around pipe in line with each shoulder. Slide gate in concrete gate structure at landside (LS) toe-not found 2013. Sewage treatement plant on waterside (WS). Control valve in concrete box on the WS. (Permit No. 3599B-1964) Contact: Sacramento Reginal Offic e 875-9400; Oscar Starks (Supervisor) 916-204-5143; Troy Shurock 916-599-2413. FS Date: 12/4/2013

View of waterward side.

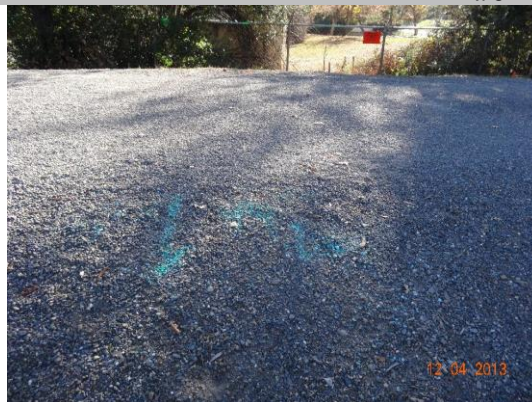
Photo 2 of 2 : UCIP_FA_2016_26298_47571.jpg

Comment Code					
Inspector Comment					
FS_ID:26298 DS_ID:24567 EP_NO: 3599A Repair Type: Non-Urgent Crossing Status: Found UCIP Comments: Need to determine status of structure. Need to coordinate with owner to determine maintenance records to confirm integrity. FIELD_STRUCT_DESC: 2 of 3: [River Walkway Station] 36-inch concrete encased pipe through the levee, 6.9 feet below the crown. Two cutoff walls around pipe in line with each shoulder. Slide gate in concrete gate structure at landside (LS) toe. Sewage treatment plant on waterside (WS). Control valve in concrete box on the WS. (Permit No. 3599A-1964) Contact: Sacramento Regional Office 875-9400; Oscar Starks (Supervisor) 916-204-5143; Troy Shurock 916-599-2413. FS Date: 12/4/2013

USA markers indicate alignment through levee crown.

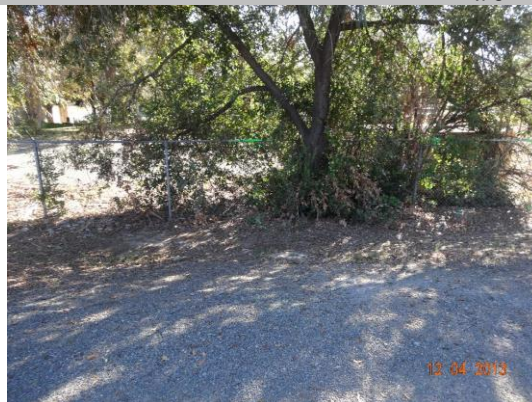
Photo 2 of 2 : UCIP_FA_2016_26426_47980.jpg

Comment Code					
Inspector Comment					
FS_ID:26426 DS_ID:24098 EP_NO: 3599 Repair Type: Non-Urgent Crossing Status: Indicator Found UCIP Comments: Need to determine status of structure--unable to determine if crossing is still being used. Underground service alert (USA) flag indicates 60 inch pipe through levee. Need to clarify. FIELD_STRUCT_DESC: 3 of 3: [River Walkway Station] 54-inch concrete encased pipe through the levee, 8.5 feet below the crown. Two cutoff walls around pipe in line with each shoulder. Slide gate in concrete gate structure at landside (LS) toe. Sewage treatment plant on waterside (WS). Control valve in concrete box on the WS. (Permit No. 3599-1964) Contact: Sacramento Reginal Office 875-9400; Oscar Starks (Supervisor) 916-204-5143; Troy Shurock 916-599-2413. FS Date: 12/4/2013

View of Underground Service Alert (USA) markers and flags confirming buried sewer lines.

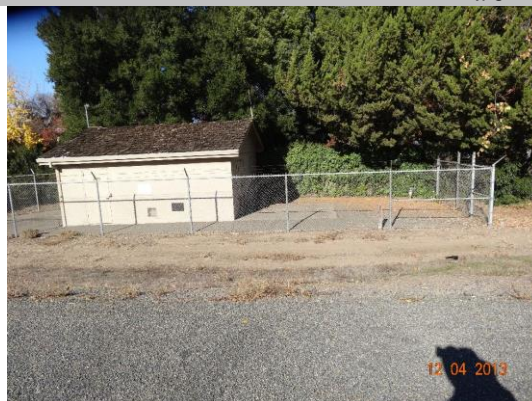
Photo 1 of 2 : UCIP_FA_2016_41548_54880.jpg

FS_ID:41548
DS_ID:24419
EP_NO: N/A
Repair Type: Non-Urgent
Crossing Status: Found
UCIP Comments: Need to find out the status of crossing--unable to determine if crossing is being used.
FIELD_STRUCT_DESC: 24-inch pipe through the levee, 7.0 feet below the crown. Concrete inspection box at waterside (WS) toe.
FS Date: 12/4/2013

Structure located on landward side.

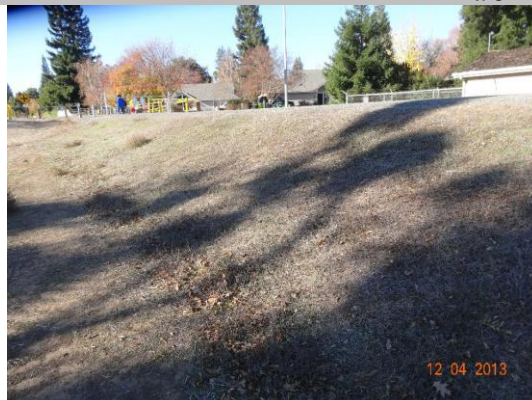
Photo 2 of 2 : UCIP_FA_2016_41548_54881.jpg

View of waterward side.

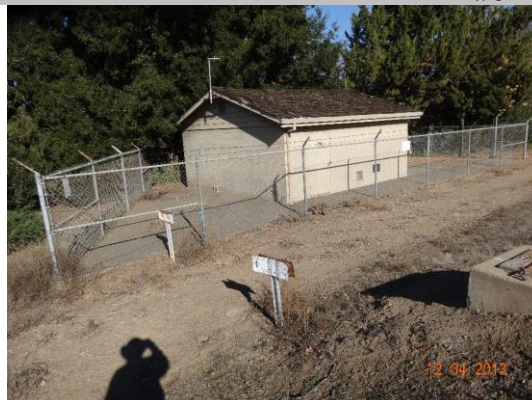
Photo 2 of 2 : UCIP_FA_2016_41546_57289.jpg

LM Start	1.53	Rating **	M	Issue No.	127
LM End	1.53	Issue Type +	En	Location *	CR
Category	Supplemental			GPS Latitude/Longitude	
				Start	End
Item	DWR UCIP Field Study			38.581588 °	38.581588 °
				-121.343631 °	-121.343631 °
DWR ID					
Comment Code					
Inspector Comment					
FS_ID:41546					
DS_ID:24101					
EP_NO: N/A					
Repair Type: Non-Urgent					
Crossing Status: Found					
UCIP Comments: Need to determine the status of crossing--unable to determine if crossing is still active.					
FIELD_STRUCT_DESC: 8-inch pipe through the levee. Concrete inspection box on the landside (LS) slope.					
FS Date: 12/4/2013

View of landward side--chlorine line adjacent to 8-inch pipe.

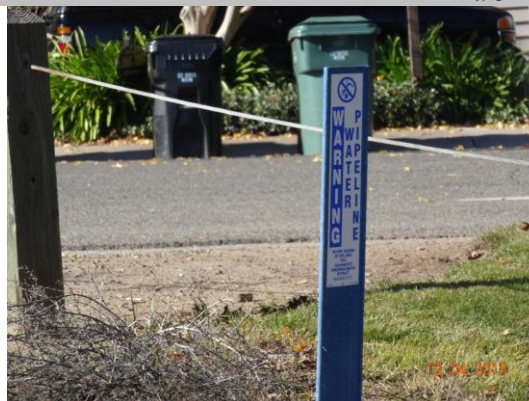
Photo 1 of 2 : UCIP_FA_2016_30575_56338.jpg

FS_ID:30575
DS_ID:24822
EP_NO: N/A
Repair Type: Non-Urgent
Crossing Status: Indicator Found
UCIP Comments: 2nd marker visible on landward side at levee mile 1.63 (38.581564 -121.343806).
FIELD_STRUCT_DESC: Marker indicating water line located on landside (LS) toe. Unable to determine if line runs parallel to levee or if line crosses levee. Unable to find permit for work.
FS Date: 12/4/2013

Waterline marker at levee mile 1.63.

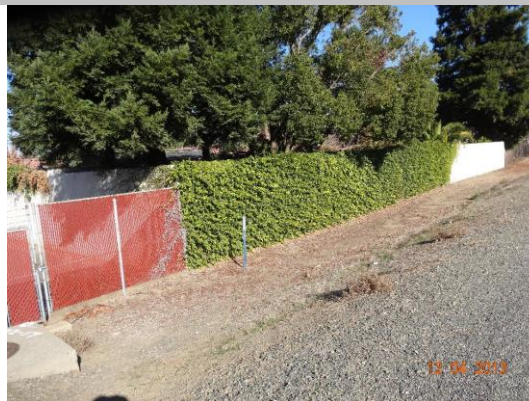
Photo 2 of 2 : UCIP_FA_2016_30575_56337.jpg

Waterline marker at levee mile 1.7.

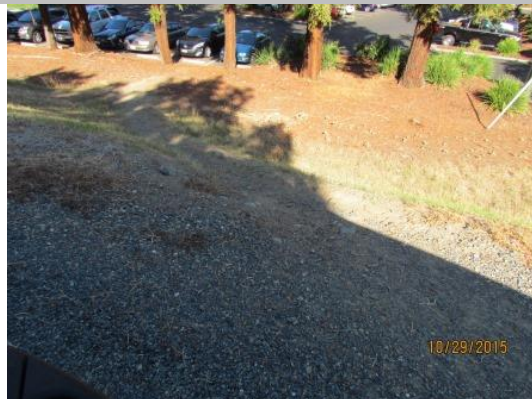
Photo 1 of 1 : FA_2016_NA0001_61_21_20160914_00005.jpg

LM Start	3.49	Rating **	A/W	Issue No.	21
LM End	3.49	Issue Type +	Ma	Location *	LS
Category	Earthen Levee			GPS Latitude/Longitude	
				Start	End
Item	Slope Stability			38.569484 °	38.569484 °
				-121.375841 °	-121.375841 °
DWR ID	DWR_NA0001_10_f_2015_21				
Comment Code					
S2 : Repair the levee slope damaged by foot traffic and prevent access where possible.					
Inspector Comment

View of the footpath on the landside levee slope.

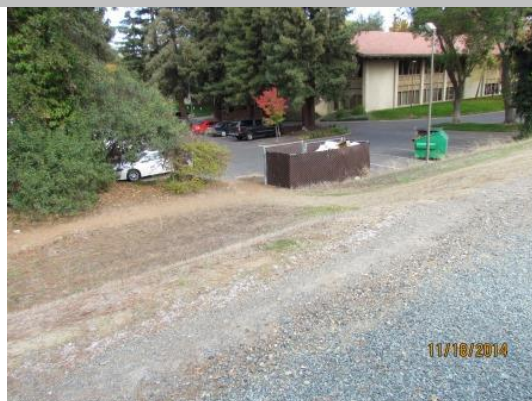
Photo 1 of 1 : FA_2016_NA0001_61_116_20160914_00008.jpg

LM Start	3.74	Rating **	A/W	Issue No.	116
LM End	3.74	Issue Type +	Ma	Location *	LS
Category	Earthen Levee			GPS Latitude/Longitude	
				Start	End
Item	Slope Stability			38.568526 °	38.568526 °
				-121.380331 °	-121.380331 °
DWR ID	DWR_NA0001_10_s_2012_116				
Comment Code					
S2 : Repair the levee slope damaged by foot traffic and prevent access where possible.					
Inspector Comment					
Foot traffic is eroding the landside slope.

View of the erosion on the landside levee slope caused by pedestrian foot traffic.

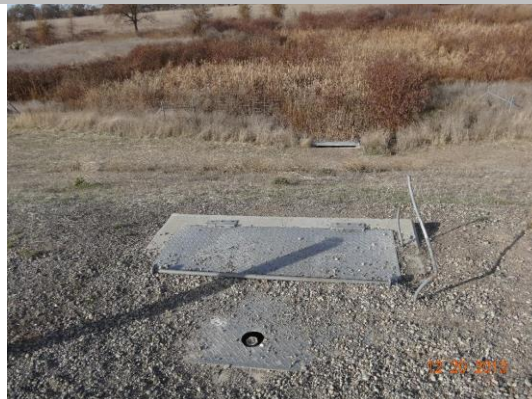
Photo 1 of 2 : UCIP_FA_2016_31310_57345.jpg

FS_ID:31310
DS_ID:24823
EP_NO: N/A
Repair Type: Non-Urgent
Crossing Status: Found
UCIP Comments: no permit found--owner? (unauthorized?)
FIELD_STRUCT_DESC: 24-inch pipe through the levee at unknown depth. Concrete box located on waterside (WS) shoulder. Concrete wall located on waterside (WS) and landside (LS). Siphon breaker inside concrete service box located on WS shoulder. No permit found.
FS Date: 12/20/2013

View of waterward side.

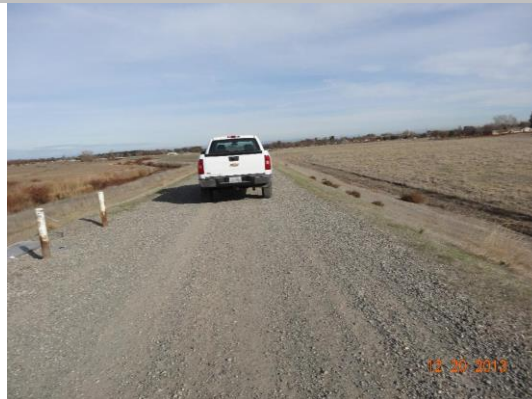
Photo 2 of 2 : UCIP_FA_2016_31310_57342.jpg

View of levee crown at crossing.

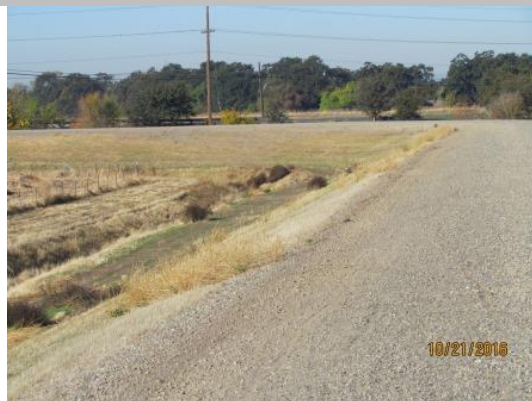
Photo 1 of 1 : FA_2016_NA0001_436_5_20161031_00009.jpg

LM Start	0.46	Rating **	A	Issue No.	5
LM End	0.68	Issue Type +	Ma	Location *	LS
Category	Earthen Levee			GPS Latitude/Longitude	
				Start	End
Item	Vegetation			38.666500 °	38.667916 °
				-121.451420 °	-121.448362 °
DWR ID	DWR_NA0001_11_f_2016_5				
Comment Code					
V1 : Control annual grass and weeds on the levee slopes and easements.					
Inspector Comment					
Acceptable vegetation control.

View of the vegetation on the landside levee slope.

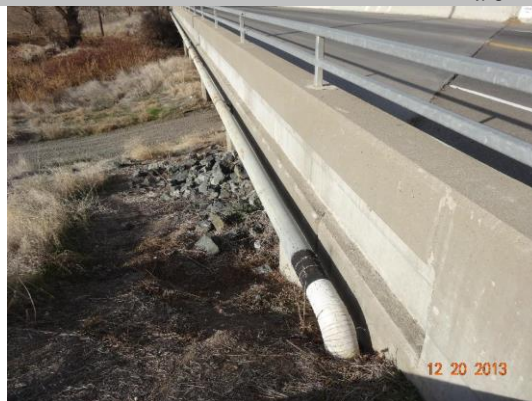
Photo 1 of 1 : UCIP_FA_2016_31311_57346.jpg

LM Start	0.48	Rating **	M	Issue No.	7
LM End	0.48	Issue Type +	En	Location *	LS
Category	Supplemental			GPS Latitude/Longitude	
				Start	End
Item	DWR UCIP Field Study			38.666585 °	38.666585 °
				-121.451009 °	-121.451009 °
DWR ID					
Comment Code					
Inspector Comment					
FS_ID:31311					
DS_ID:24824					
EP_NO: N/A					
Repair Type: Non-Urgent					
Crossing Status: Found					
UCIP Comments: owner? permit? (unauthorized?)					
FIELD_STRUCT_DESC: 6 inch conduit through levee at unknown					
depth. Conduit extends across the channel, attached to bridge.					
FS Date: 12/20/2013

Crossing visible on waterward side.

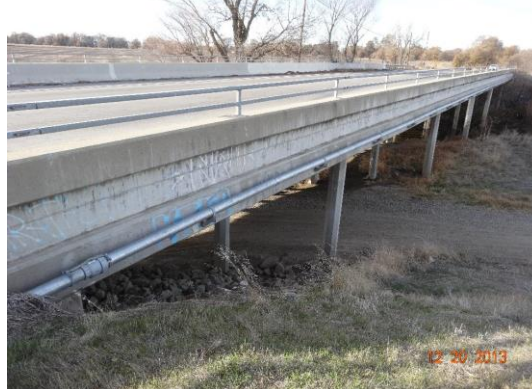
Photo 1 of 1 : UCIP_FA_2016_31312_57347.jpg

LM Start	0.49	Rating **	M	Issue No.	8
LM End	0.49	Issue Type +	En	Location *	LS
Category	Supplemental			GPS Latitude/Longitude	
				Start	End
Item	DWR UCIP Field Study			38.666745 °	38.666745 °
				-121.450918 °	-121.450918 °
DWR ID					
Comment Code					
Inspector Comment					
FS_ID:31312					
DS_ID:24825					
EP_NO: N/A					
Repair Type: Non-Urgent					
Crossing Status: Found					
UCIP Comments: owner? permit? (unauthorized?)					
FIELD_STRUCT_DESC: 4 inch conduit through levee at unknown					
depth. Conduit extends across the channel, attached to bridge.					
FS Date: 12/20/2013

Conduit attached to the upstream face of Rio Linda Blvd Bridge.

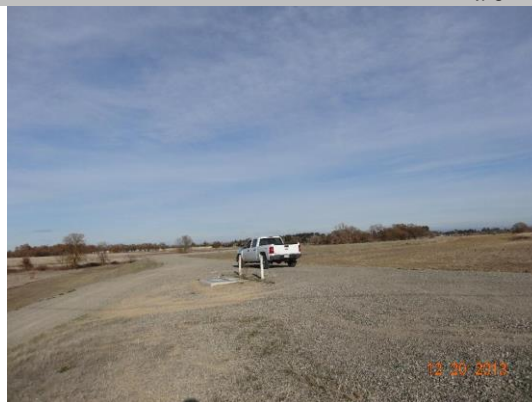
Photo 1 of 2 : UCIP_FA_2016_31313_57349.jpg

LM Start	0.52	Rating **	M	Issue No.	9
LM End	0.52	Issue Type +	En	Location *	LS
Category	Supplemental			GPS Latitude/Longitude	
				Start	End
Item	DWR UCIP Field Study			38.667108 °	38.667108 °
				-121.450827 °	-121.450827 °
DWR ID					
Comment Code					
Inspector Comment					
FS_ID:31313					
DS_ID:24826					
EP_NO: N/A					
Repair Type: Non-Urgent					
Crossing Status: Found					
UCIP Comments: owner? permit? (unauthorized?)					
FIELD_STRUCT_DESC: 24-inch (estimate only field verify) storm drain pipe through levee at an unknow depth. Concrete headwalls with debris screens located on waterside (WS) and landside (LS). Concrete box with protective posts located on WS shoulder. No permit found.					
FS Date: 12/20/2013

View of levee crown at crossing.

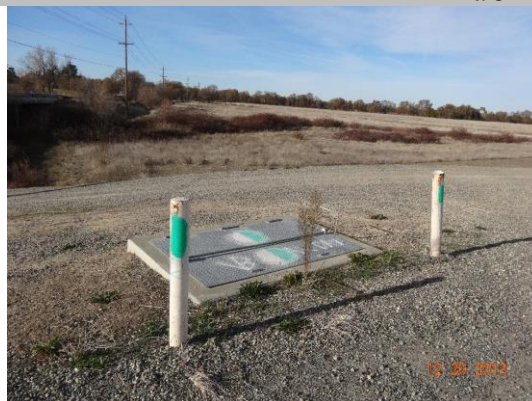
Photo 2 of 2 : UCIP_FA_2016_31313_57348.jpg

LM Start	0.52	Rating **	M	Issue No.	9 (cont)	
LM End	0.52	Issue Type +	En	Location *	LS	
Category	Supplemental			GPS Latitude/Longitude		
				Start	End	
Item	DWR UCIP Field Study			38.667108 °	38.667108 °	
				-121.450827 °	-121.450827 °	
DWR ID						
Comment Code						
Inspector Comment						
FS_ID:31313 DS_ID:24826 EP_NO: N/A Repair Type: Non-Urgent Crossing Status: Found UCIP Comments: owner? permit? (unauthorized?) FIELD_STRUCT_DESC: 24-inch (estimate only field verify) storm drain pipe through levee at an unknow depth. Concrete headwalls with debris screens located on waterside (WS) and landside (LS). Concrete box with protective posts located on WS shoulder. No permit found. FS Date: 12/20/2013

Concrete vault with protective posts located on waterward shoulder.

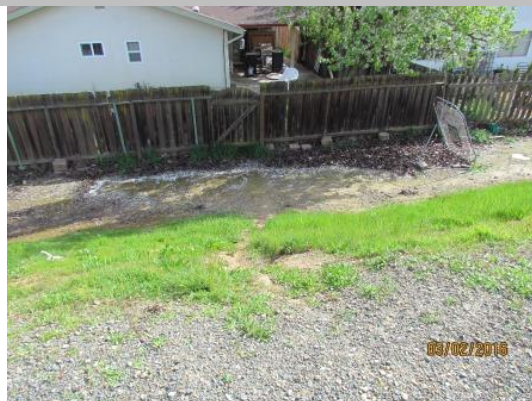
Photo 1 of 1 : FA_2016_NA0001_438_4_20160914_00004.jpg

LM Start	0.56	Rating **	A/W	Issue No.	4
LM End	0.56	Issue Type +	Ma	Location *	LS
Category	Earthen Levee			GPS Latitude/Longitude	
				Start	End
Item	Slope Stability			38.575370 °	38.575370 °
				-121.346583 °	-121.346583 °
DWR ID	DWR_NA0001_12_f_2015_4				
Comment Code					
S2 : Repair the levee slope damaged by foot traffic and prevent access where possible.					
Inspector Comment

View of the footpath on the landside levee slope.

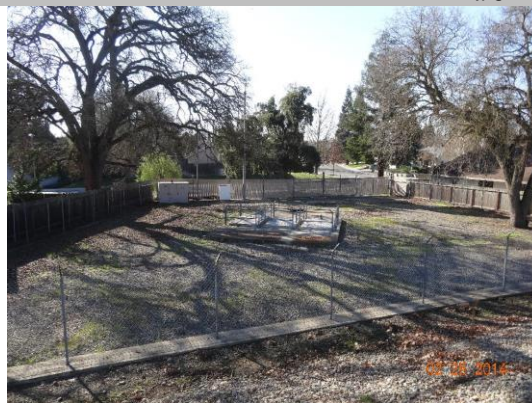
Photo 1 of 2 : UCIP_FA_2016_46995_56234.jpg

Comment Code					
Inspector Comment					
FS_ID:46995 DS_ID:24830 EP_NO: N/A Repair Type: Non-Urgent Crossing Status: Indicator Found UCIP Comments: Unable to confirm pipe size--need to contact owner to obtain additional information on crossing. FIELD_STRUCT_DESC: [SRCSD Facility N16 NE Siphon Outlet] 1 of 3: 48-inch reinforced concrete (RC) drainpipe through the levee at 11.0 feet below crown. Pipe crosses levee at an angle. Sacramento Regional County Sanitation District (SRCSD) Facility N16 NE Siphon Outlet located on landside (LS). Facility is fenced off. Inside facility are 3 concrete boxes with 3 manholes. (Permit No. 12144-1978, SRCSD and 12144-A-1983, SRCSD for cathodic protection) FS Date: 2/25/2014

Concrete vault located on landward side.

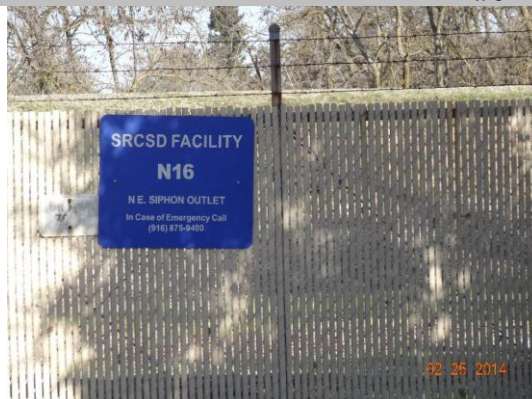
Photo 2 of 2 : UCIP_FA_2016_46995_56235.jpg

Comment Code						
Inspector Comment						
FS_ID:46995 DS_ID:24830 EP_NO: N/A Repair Type: Non-Urgent Crossing Status: Indicator Found UCIP Comments: Unable to confirm pipe size--need to contact owner to obtain additional information on crossing. FIELD_STRUCT_DESC: [SRCSD Facility N16 NE Siphon Outlet] 1 of 3: 48-inch reinforced concrete (RC) drainpipe through the levee at 11.0 feet below crown. Pipe crosses levee at an angle. Sacramento Regional County Sanitation District (SRCSD) Facility N16 NE Siphon Outlet located on landside (LS). Facility is fenced off. Inside facility are 3 concrete boxes with 3 manholes. (Permit No. 12144-1978, SRCSD and 12144-A-1983, SRCSD for cathodic protection) FS Date: 2/25/2014

SRCSD Facility N16, NE Siphon Outlet, sign visible from Mira Del Rio Drive.

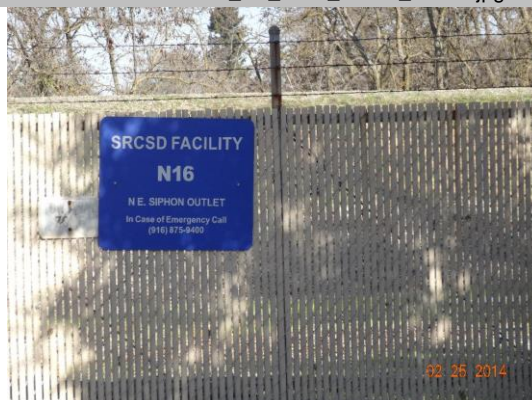
Photo 1 of 2 : UCIP_FA_2016_30540_56232.jpg

Comment Code					
Inspector Comment					
FS_ID:30540 DS_ID:24829 EP_NO: N/A Repair Type: Non-Urgent Crossing Status: Indicator Found UCIP Comments: Unable to confirm pipe size--need to contact owner to obtain additional information on crossing. FIELD_STRUCT_DESC: [SRCSD Facility N16 NE Siphon Outlet] 2 of 3: 48-inch reinforced concrete (RC) drainpipe through the levee at 11.0 feet below crown. Pipe crosses levee at an angle. Sacramento Regional County Sanitation District (SRCSD) Facility N16 NE Siphon Outlet located on landside (LS). Facility is fenced off. Inside facility are 3 concrete boxes with 3 manholes. (Permit No. 12144-1978, SRCSD and 12144-A-1983, SRCSD for cathodic protection) FS Date: 2/25/2014

SRCSD Facility N16, NE Siphon Outlet, sign visible from Mira Del Rio Drive.

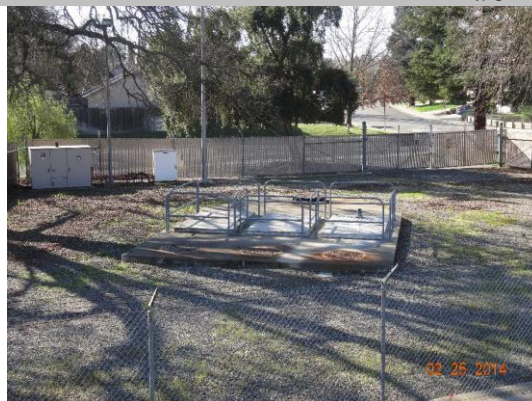
Photo 2 of 2 : UCIP_FA_2016_30540_56230.jpg

Comment Code						
Inspector Comment						
FS_ID:30540 DS_ID:24829 EP_NO: N/A Repair Type: Non-Urgent Crossing Status: Indicator Found UCIP Comments: Unable to confirm pipe size--need to contact owner to obtain additional information on crossing. FIELD_STRUCT_DESC: [SRCSD Facility N16 NE Siphon Outlet] 2 of 3: 48-inch reinforced concrete (RC) drainpipe through the levee at 11.0 feet below crown. Pipe crosses levee at an angle. Sacramento Regional County Sanitation District (SRCSD) Facility N16 NE Siphon Outlet located on landside (LS). Facility is fenced off. Inside facility are 3 concrete boxes with 3 manholes. (Permit No. 12144-1978, SRCSD and 12144-A-1983, SRCSD for cathodic protection) FS Date: 2/25/2014

Manholes visible on landward side.

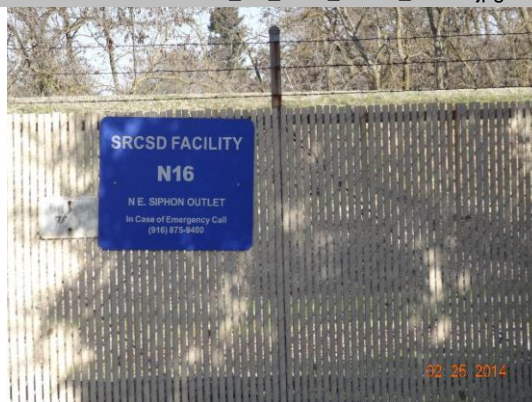
Photo 1 of 2 : UCIP_FA_2016_46994_56229.jpg

Comment Code					
Inspector Comment					
FS_ID:46994 DS_ID:24828 EP_NO: N/A Repair Type: Non-Urgent Crossing Status: Indicator Found UCIP Comments: Unable to confirm pipe size--need to contact owner to obtain additional information on crossing. FIELD_STRUCT_DESC: [SRCSD Facility N16 NE Siphon Outlet] 3 of 3: 48-inch reinforced concrete (RC) drainpipe through the levee at 11.0 feet below crown. Pipe crosses levee at an angle. Sacramento Regional County Sanitation District (SRCSD) Facility N16 NE Siphon Outlet located on landside (LS). Facility is fenced off. Inside facility are 3 concrete boxes with 3 manholes. (Permit No. 12144-1978, SRCSD and 12144-A-1983, SRCSD for cathodic protection) FS Date: 2/25/2014

SRCSDS Facility N16, NE Siphon Outlet, sign visible from Mira Del Rio Drive.

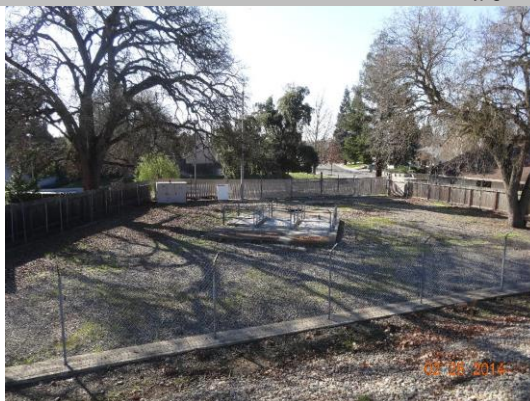
Photo 2 of 2 : UCIP_FA_2016_46994_56228.jpg

Comment Code					
Inspector Comment					
FS_ID:46994 DS_ID:24828 EP_NO: N/A Repair Type: Non-Urgent Crossing Status: Indicator Found UCIP Comments: Unable to confirm pipe size--need to contact owner to obtain additional information on crossing. FIELD_STRUCT_DESC: [SRCSD Facility N16 NE Siphon Outlet] 3 of 3: 48-inch reinforced concrete (RC) drainpipe through the levee at 11.0 feet below crown. Pipe crosses levee at an angle. Sacramento Regional County Sanitation District (SRCSD) Facility N16 NE Siphon Outlet located on landside (LS). Facility is fenced off. Inside facility are 3 concrete boxes with 3 manholes. (Permit No. 12144-1978, SRCSD and 12144-A-1983, SRCSD for cathodic protection) FS Date: 2/25/2014

Concrete vault for 3 crossings located on landward side.

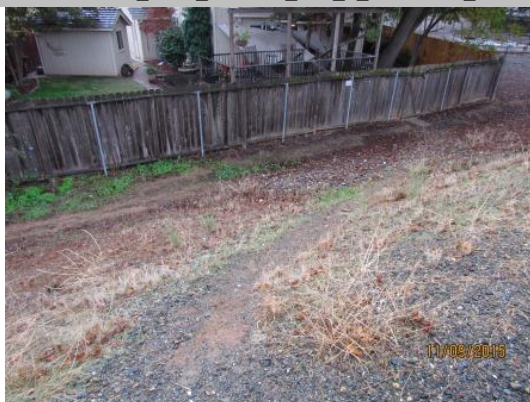
Photo 1 of 1 : FA_2016_NA0001_438_3_20160914_00003.jpg

LM Start	0.73	Rating **	A/W	Issue No.	3
LM End	0.73	Issue Type +	Ma	Location *	LS
Category	Earthen Levee			GPS Latitude/Longitude	
				Start	End
Item	Slope Stability			38.576663 °	38.576663 °
				-121.343805 °	-121.343805 °
DWR ID	DWR_NA0001_12_f_2015_3				
Comment Code					
S2 : Repair the levee slope damaged by foot traffic and prevent access where possible.					
Inspector Comment

View of the footpath on the landside levee slope.
